OPERATIONAL REPORT LESSONS LEARNED

NOV 1966 TO 31 JAN 1967

12 TH COMBAT AVIATION GROUP

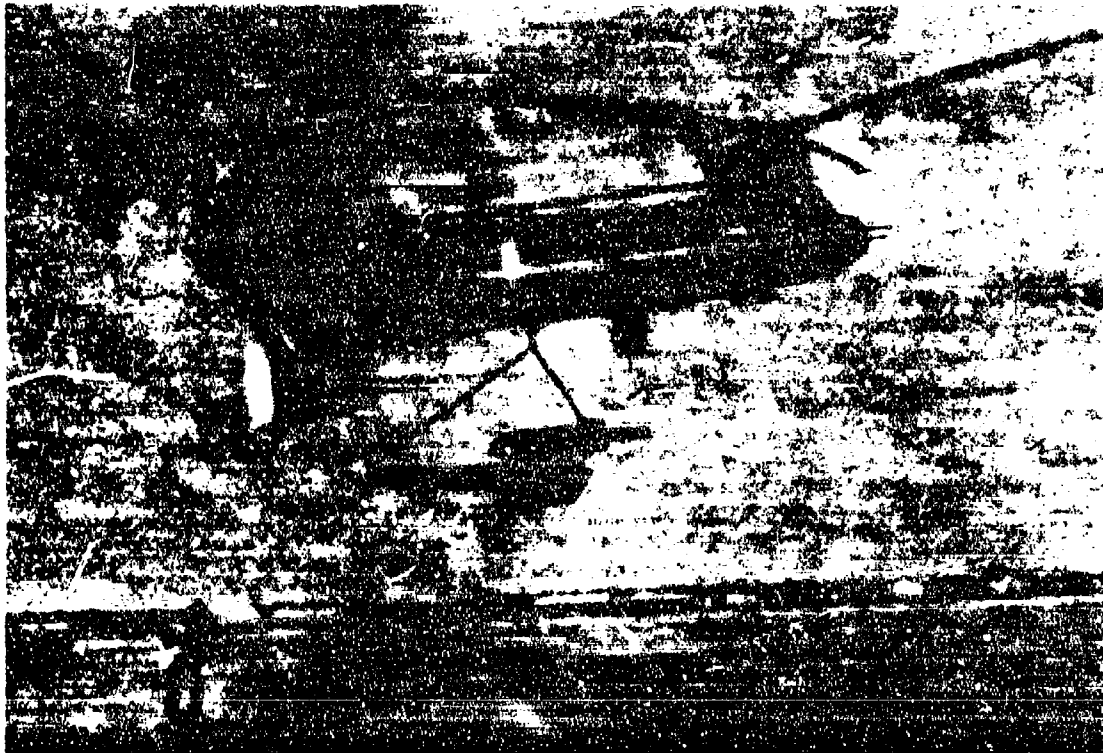
APP 1 TO AREFX K

CH-47 SLING LOADING 155MM HOWITZER (TOWED)
